MACH 6 ELECTROFORMED NICKEL NOZZLE REFURBISHMENT

FNAS Investigation of Ultra-Smooth Surfaces

NAS8-38609

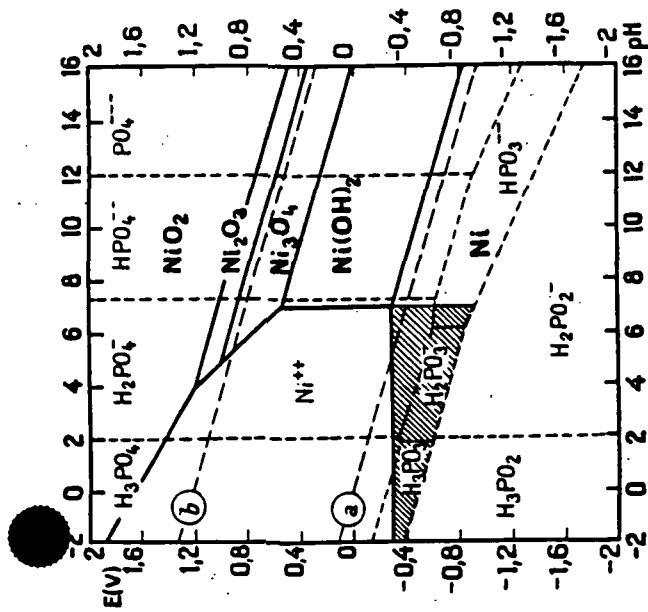
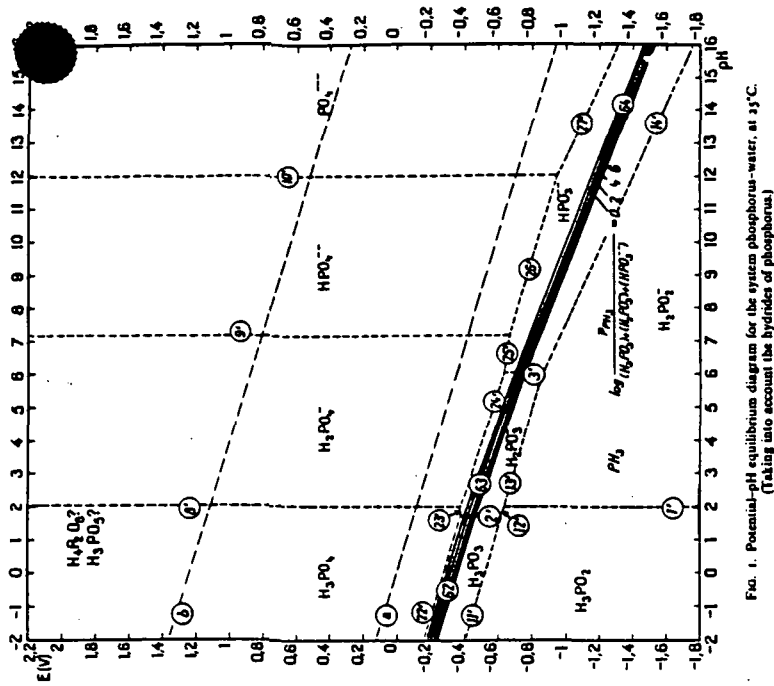
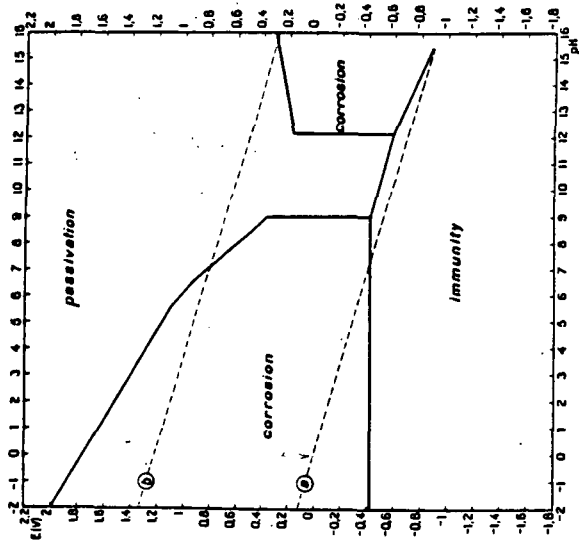
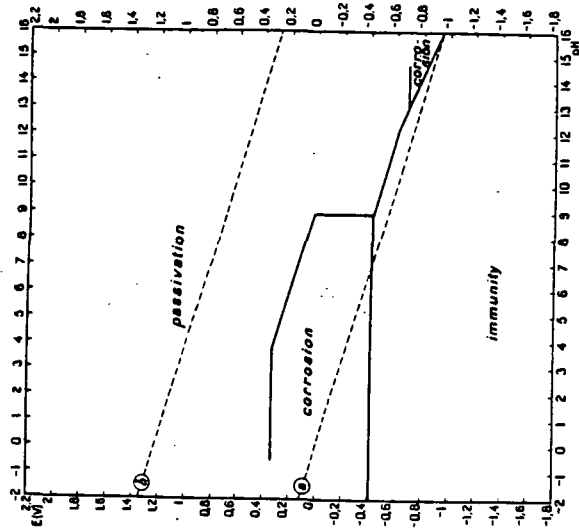
Fig. 1 Deposition and Corrosion of Nickel - phosphorous

Theoretical conditions for the formation of nickel by the reduction of Ni^{++} ions by hypophosphites.
(For solutions containing 0.6 g Ni^{++}/l .)

FIG. 1. Potential-pH equilibrium diagram for the system phosphorus-water, at 25°C.
(Taking into account the hydrides of phosphorus)

Theoretical domains of corrosion, immunity and passivation of nickel, at 25°C.

Probable experimental conditions of corrosion, immunity and passivation of nickel,
in solutions not containing chloride.

Nickel metal is subject to passivation at high oxidation potential in an oxidizing media. Phosphorous will actually improve this oxidation resistance to corrosion in the general environmental sense. However, by increasing the oxidation to much higher values than would be normally encountered in any environment, a reversal takes effect. The phosphorous alloy will then begin to dissolve while the pure nickel will further passivate. Since the nickel was encased in stainless steel, the nickel would remain slightly anodic when immersed in solution. This is due to the galvanic coupling and the noble nature of the nickel-iron-chromium alloy casing (Fig 1). Tests were performed on nickel plated, nickel-phosphorous over-plated samples. By using a very concentrated nitric acid solution it was possible to remove the alloy coating from the pure nickel deposit on these samples. Above 65% nitric acid (commercial azeotrope) the pure nickel dissolution was less than 0.0001 inch/Hr. Thus the decision to strip the part was agreed upon.

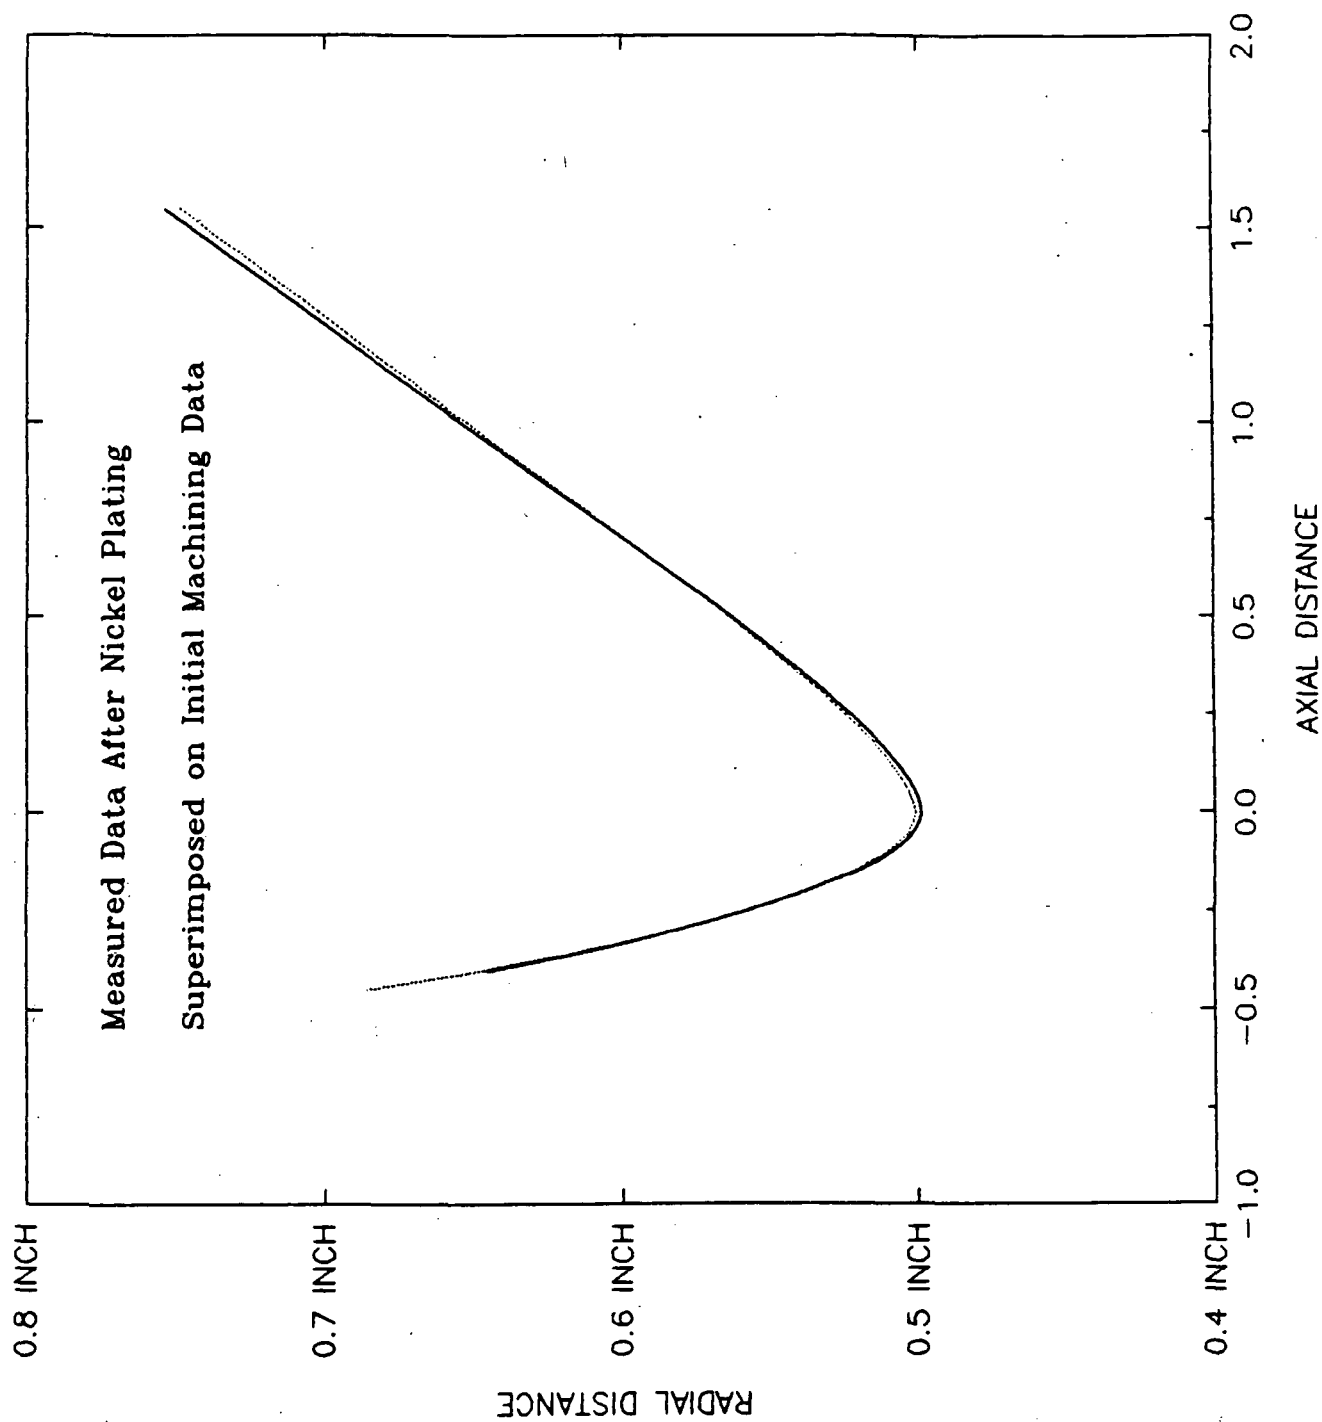
Fig 2a

Measured Data
Plotted to Original
Data

After stripping and replating the part as described, the lapping process was changed. Commercial cylinder hones were purchased and modified. The stones were removed and plastic (nylon) pads were machined and attached in place. The lapping face material and media was used as previously. The laps were rotated either with a milling machine operating horizontally or with a 1/2 inch drive drill. A small hone was used for the narrow throat area and could be drawn about three inches. A larger hone was used to polish about 35 inches of the wind tunnel. The forward section from the throat was polished by hand using the described processes. The surface profile was compared to the original data set (Fig. 2).

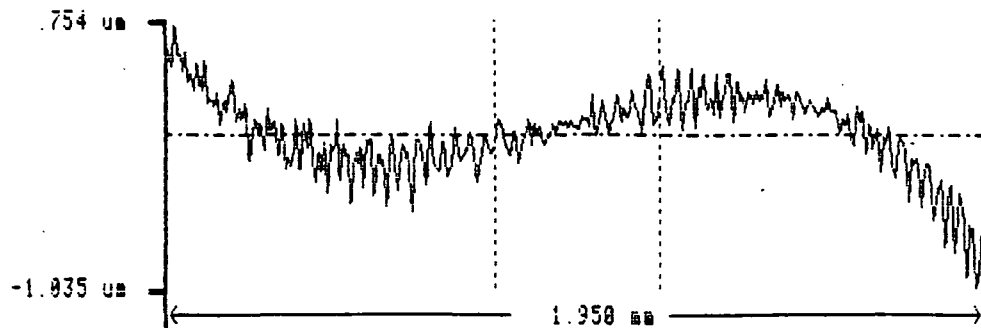
Mode	Traverse Length	Reference	Ignore
UNFILTERED	2.0 mm	CONVEX	0 %
NASA NOZZLE FINAL POLISH 1-.002

Peak To Valley = 1.789 um

Diamond Stylus 2 mm scan, Waviness Apparent;

Amplitude	=	+/- 0.900 μ m
Period	=	1.000 mm
RA	=	0.210 μ m
RMS	=	0.274 μ m
Peak to Valley	=	1.789 μ m

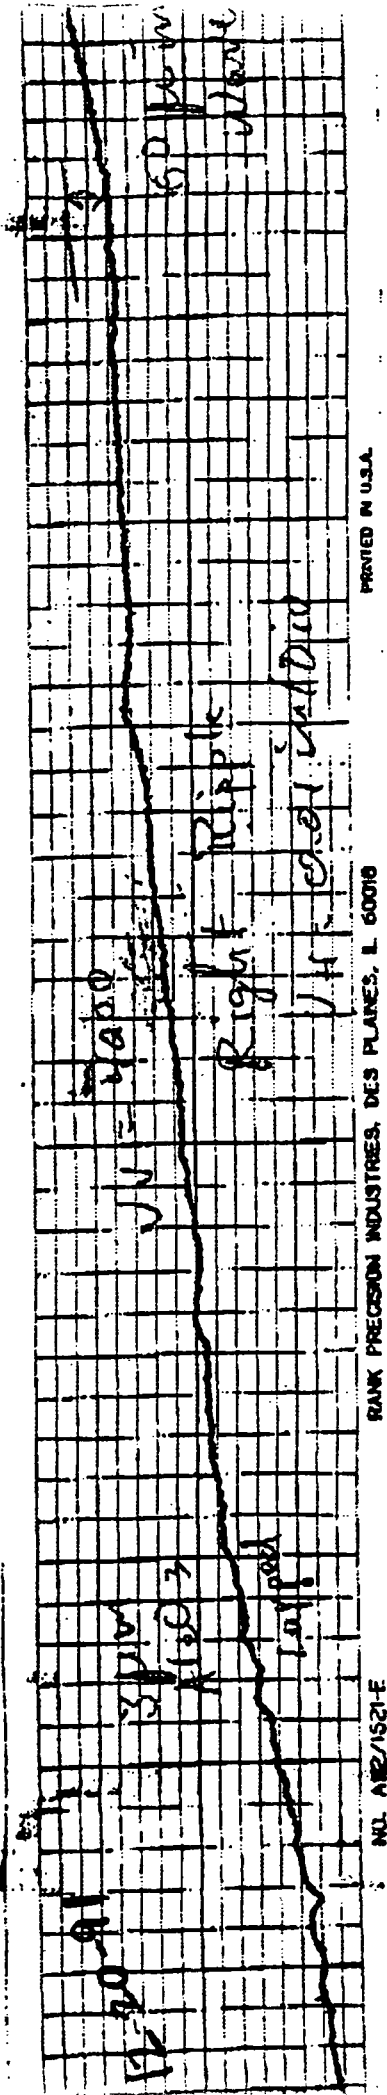
Right "Ripped" side After an Additional
1.5 Hours Polishing with 5 μm Compound
Followed by 1.0 Hours with 3 μm Compound

Fig 5a
Ripped Area
1.5 Hours Lapping
Polish #2
12-20-91

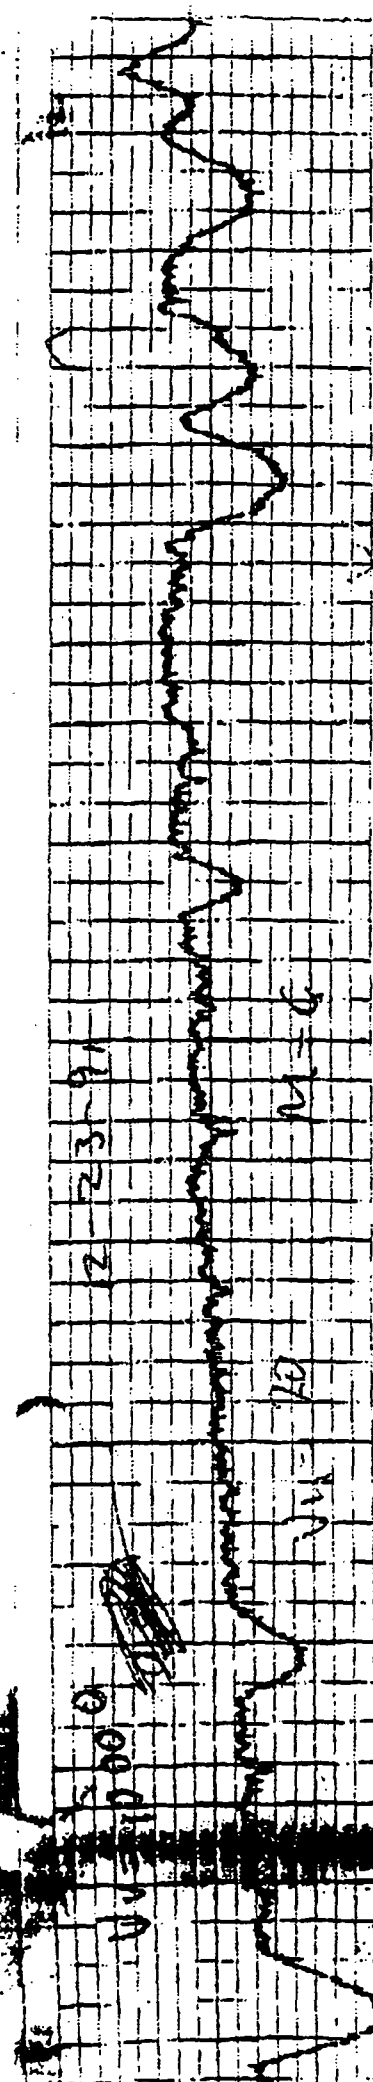
Fig 561 9.5 ± 11 9.5 0.5 inch 12-23-91

Left Side "B" Eight Hours Lapping with 3μm Compound

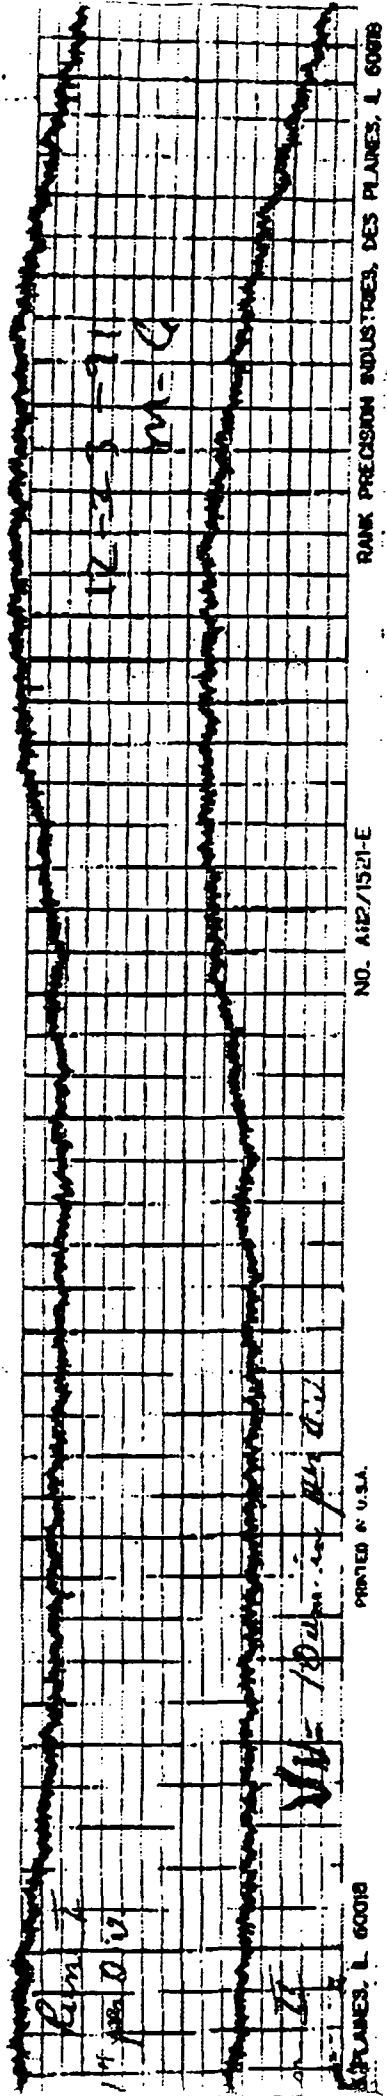
Fig 5 b2 9.5 Hours 7.1.1 Polish, #12

Smooth Area Eight Hours Lapping 3μm compound

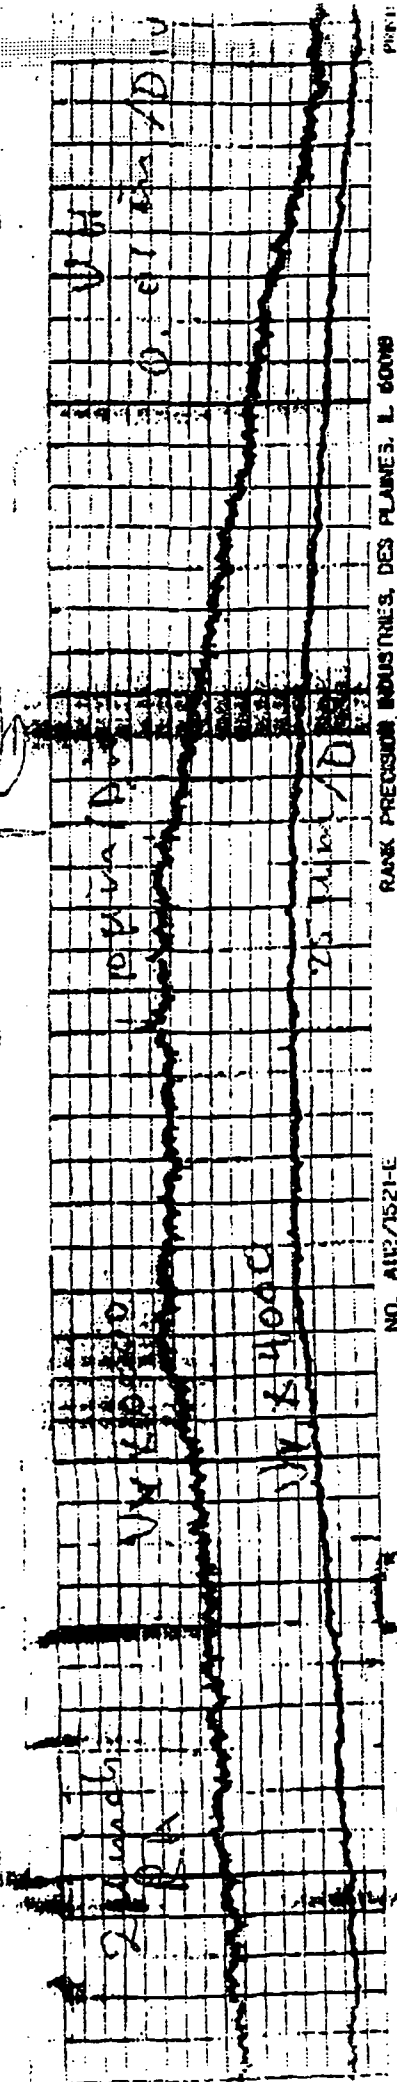
Fig 5c
Left Side "B" After Additional
1.5 Hours Polishing with 5µm Compound
Followed by 1.0 Hours with 3µm Compound

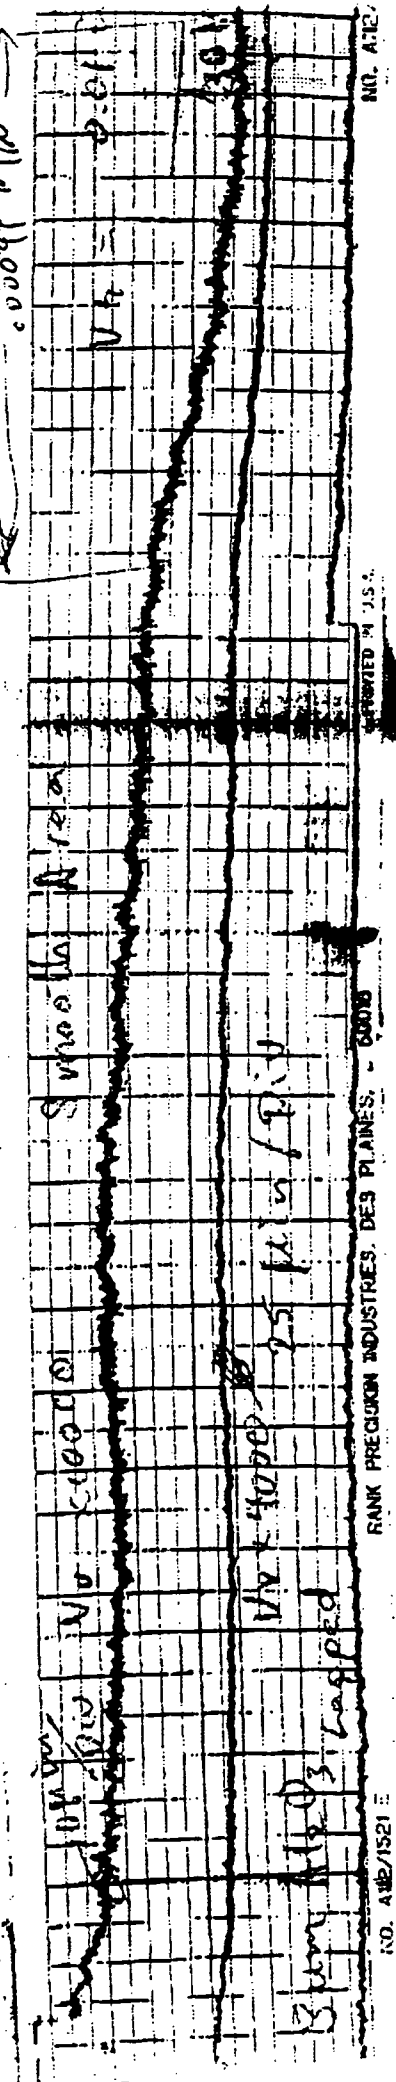
Fig 5d

"Smooth Area"

Comparison of
Dimpled vs Smooth
Area (all Hours)

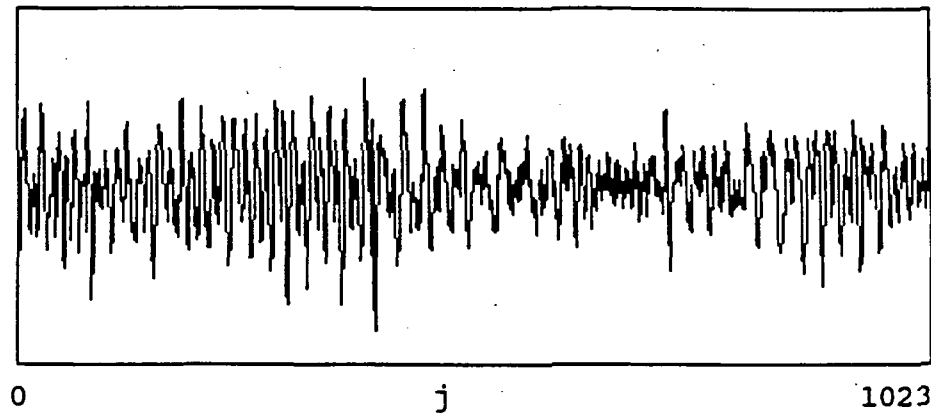
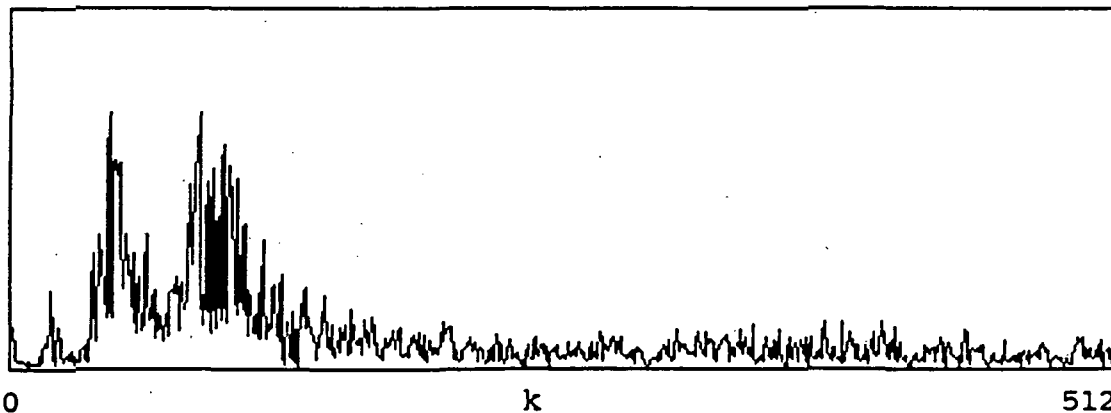
Fig. 6a

Frequency Analysis of Polishing Data
Second Polish - Note Frequency Content

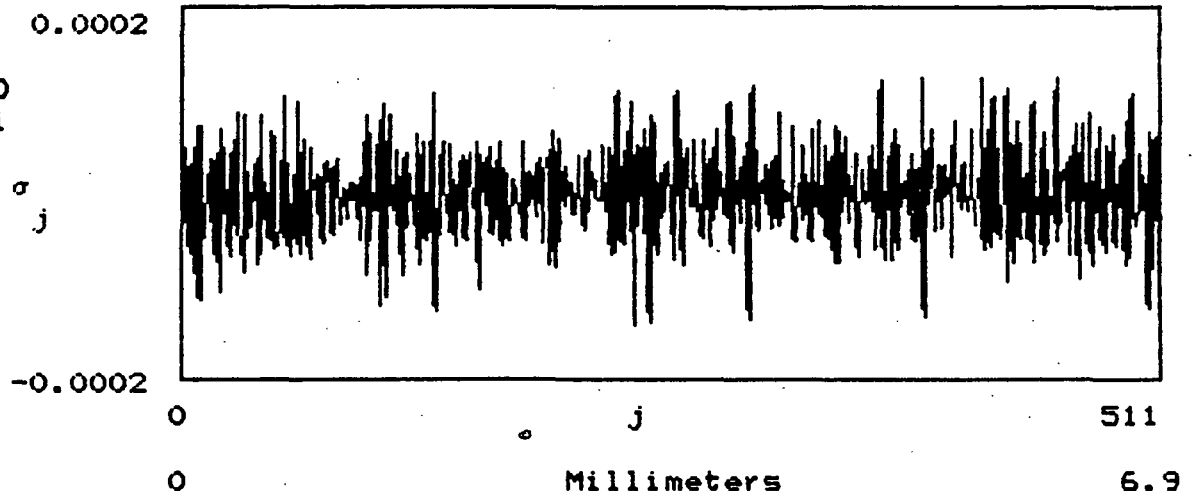
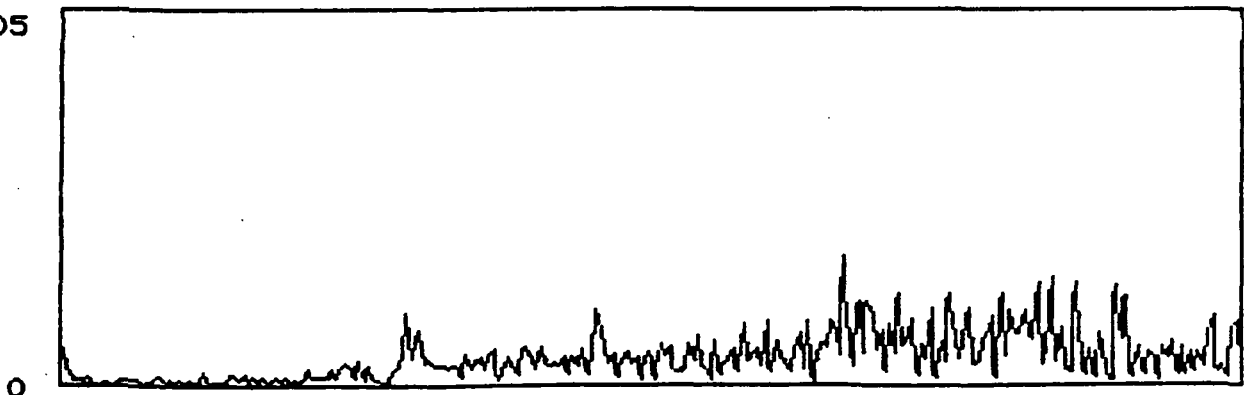
MACH 6 SCAN 3D
ELECTROLESS Ni
POLISHED
512 POINTS
DIAMOND ST
Scan Data

Fig 6 C Frequency Analysis^k of Polishing Data
Third Polish - Note smoother Freq. Spectrum

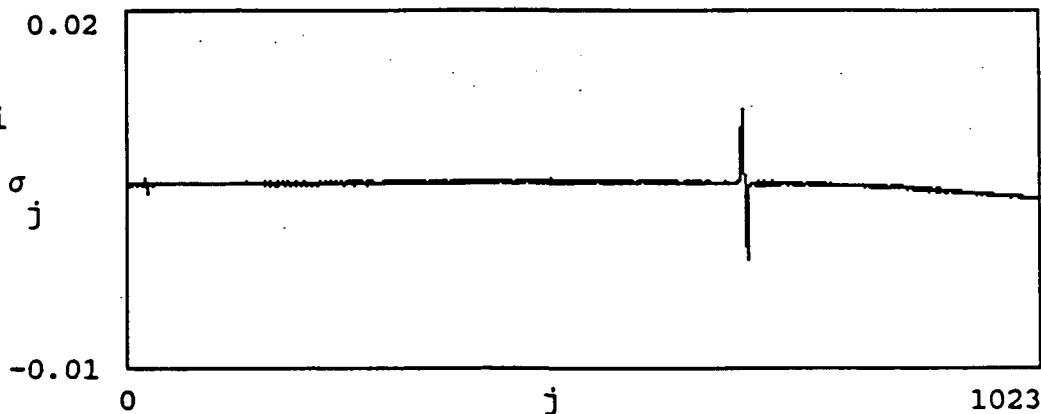
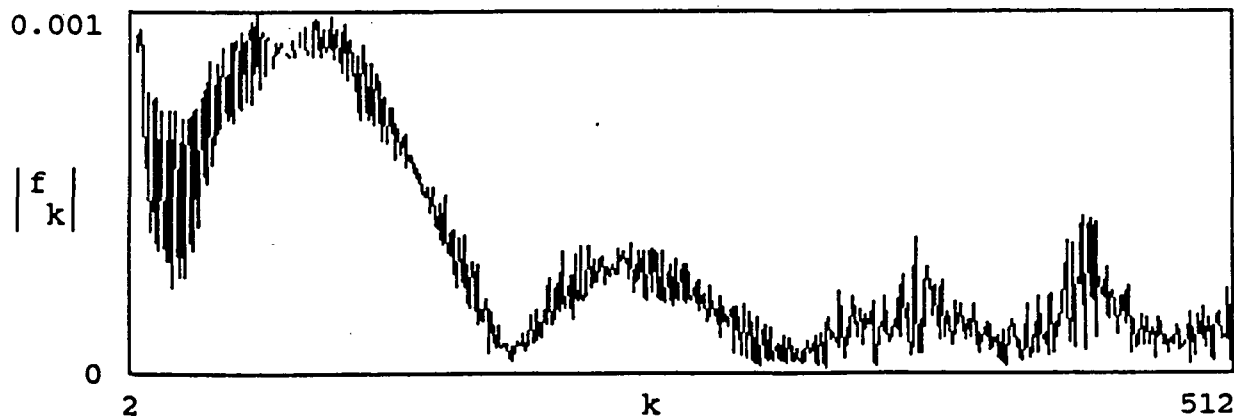
Fig 6e1

MACH 6 SCAN 2
ELECTROLESS Ni
POLISHED
1024 POINTS
RUBY STYLUS

Analysis of Measured Disturbance
Note two spikes due to
disturbance (Ruby Stylus) (Second)

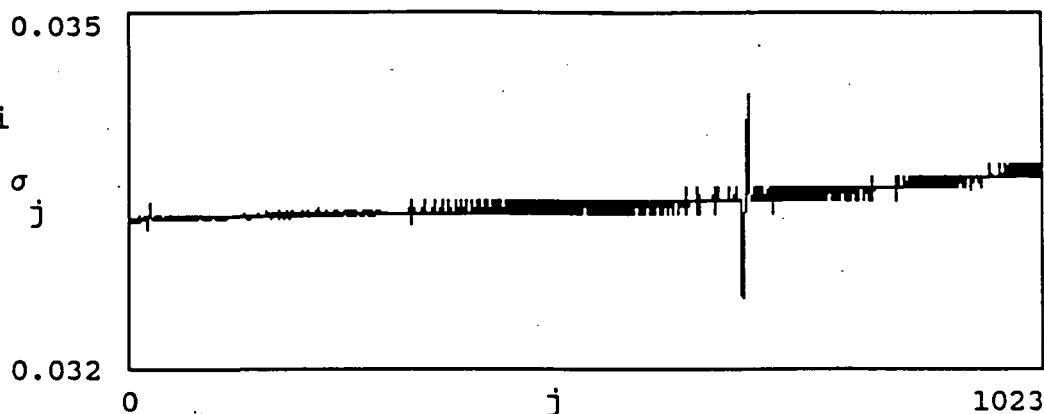
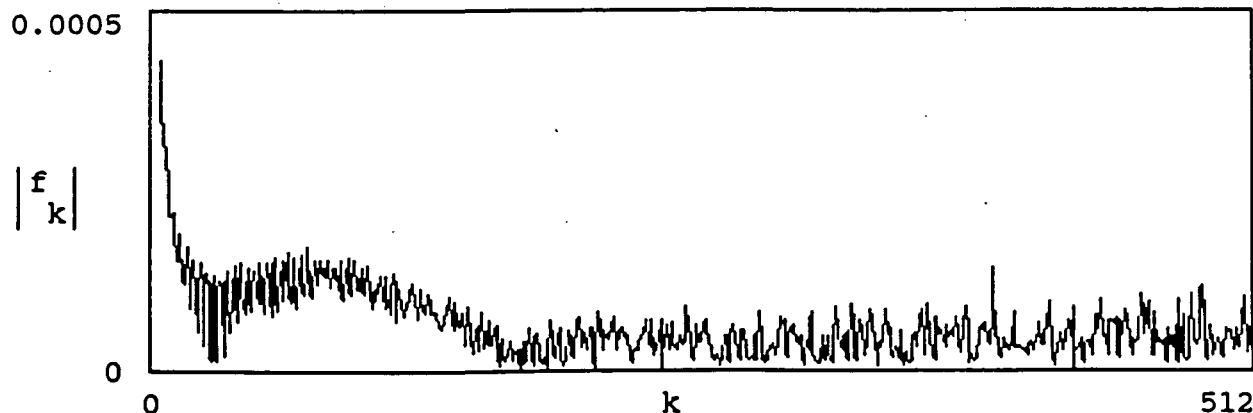
Fig. 6 f1

MACH 6 SCAN 2
ELECTROLESS Ni
POLISHED
1024 POINTS
RUBY STYLUS
Stylus Motion

Analysis of Stylus Motion (Second Polish)
Note correlation to
disturbance 6e-1 to 6e-3 (Ruby Stylus)

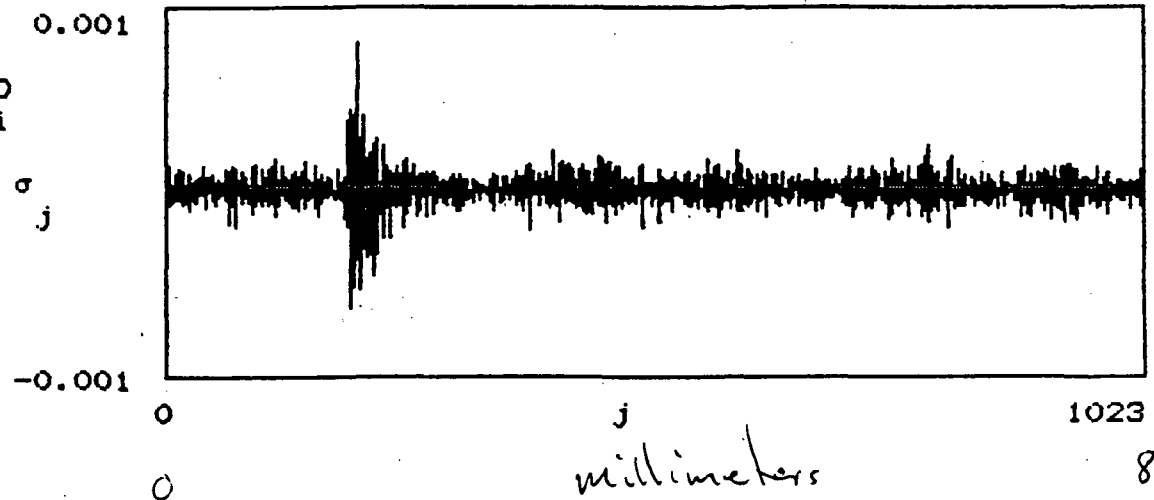
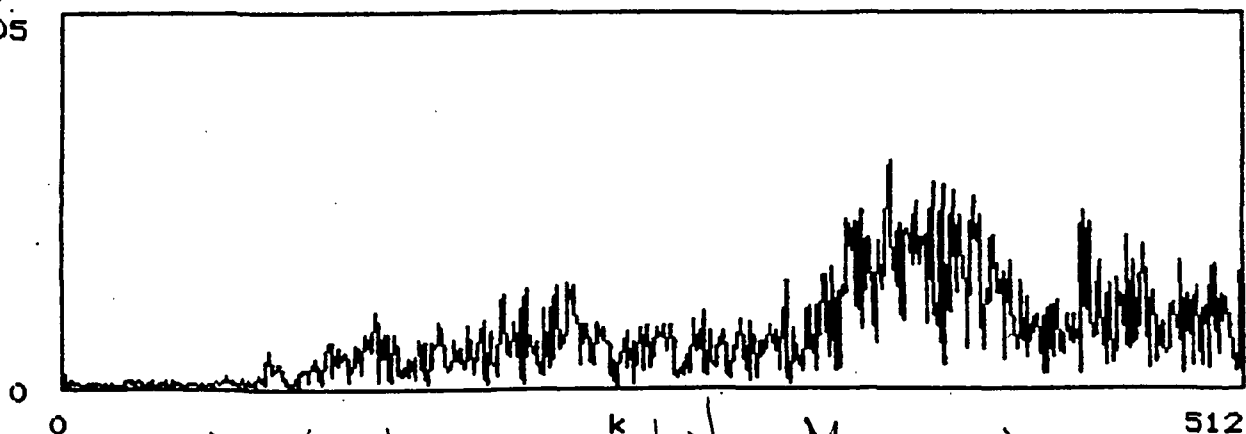
Fig. 6 g 1

MACH 6 SCAN 1D
ELECTROLESS Ni
POLISHED
1024 POINTS
DIAMOND ST
Scan Data

Disturbance while Measuring
with Diamond Stylus (Third Polish)

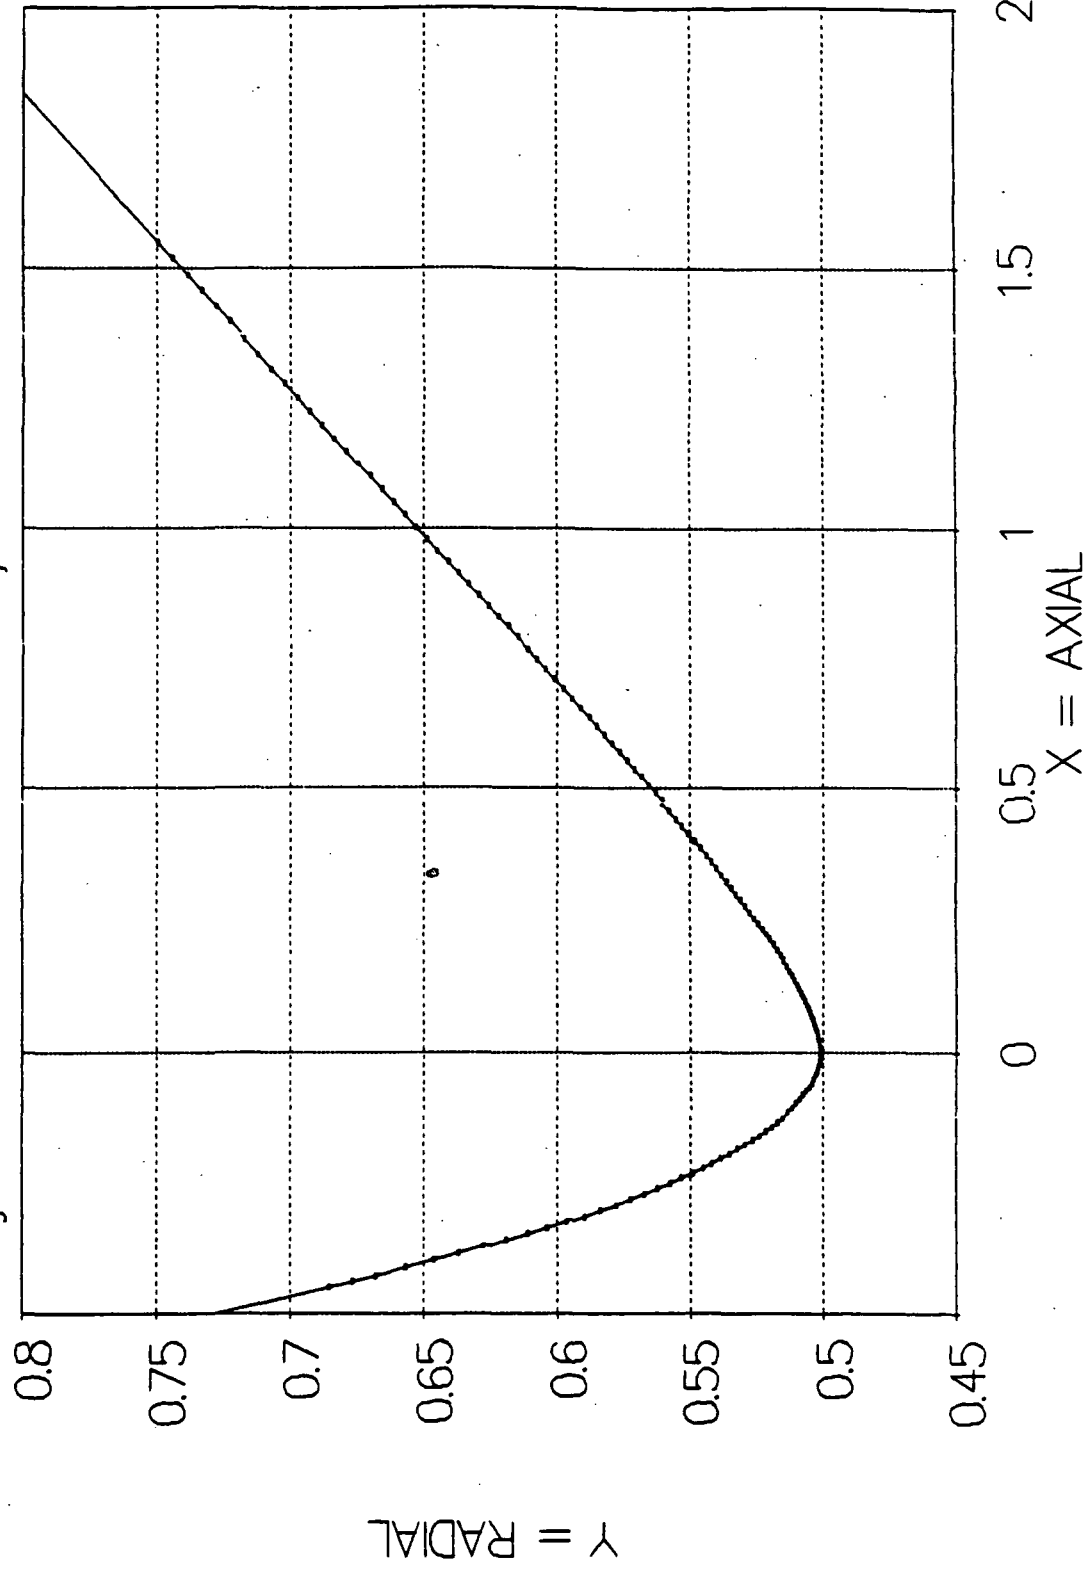
Fig 2a Polynomial Fit (Original Data)

1 Eqn 221 $y=(a+cx+ex^2+gx^3+ix^4+kx^5)/(1+bx+dx^2+fx^3+hx^4+ix^5)$ $r2=0.9999995791$
 $a=0.50139392$ $b=4.7354236$ $c=2.3745299$ $d=24.480881$ $e=12.962129$ $f=34.157869$
 $g=18.556247$ $h=22.33937$ $i=19.519794$ $j=-1.6449933$ $k=1.5775826$

7. Polynomial Surface Contour Fit

- a) Original Data Fit to Polynomial
- b) Residual Error in Fitted Original Data Polynomial
- c) Polynomial Coefficients (Original Data)
- d) Measured Data Fit to Polynomial
- d) Residual Error in Fitted Measured Data Polynomial
- e) Polynomial Coefficients (Measured Data)
- f) Original Data Set (1)
- g) Original Data Set (2)

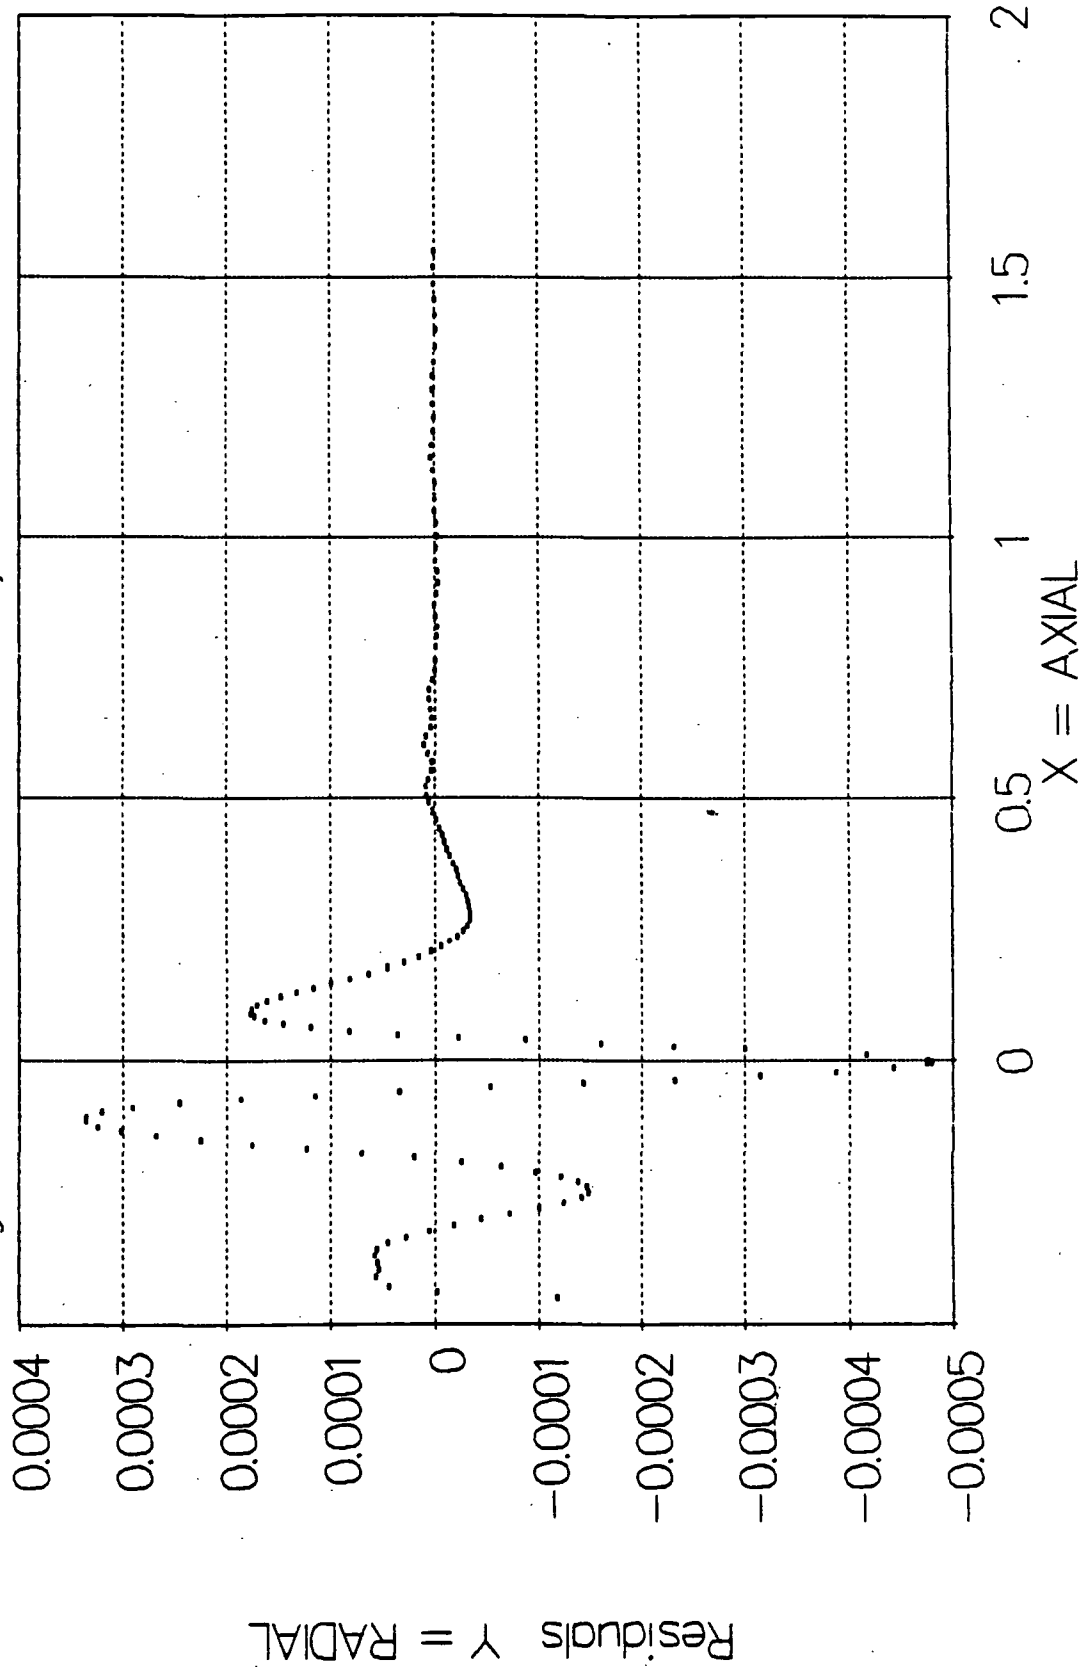
Fig 7b Residual Error at Minimum (Original Data)

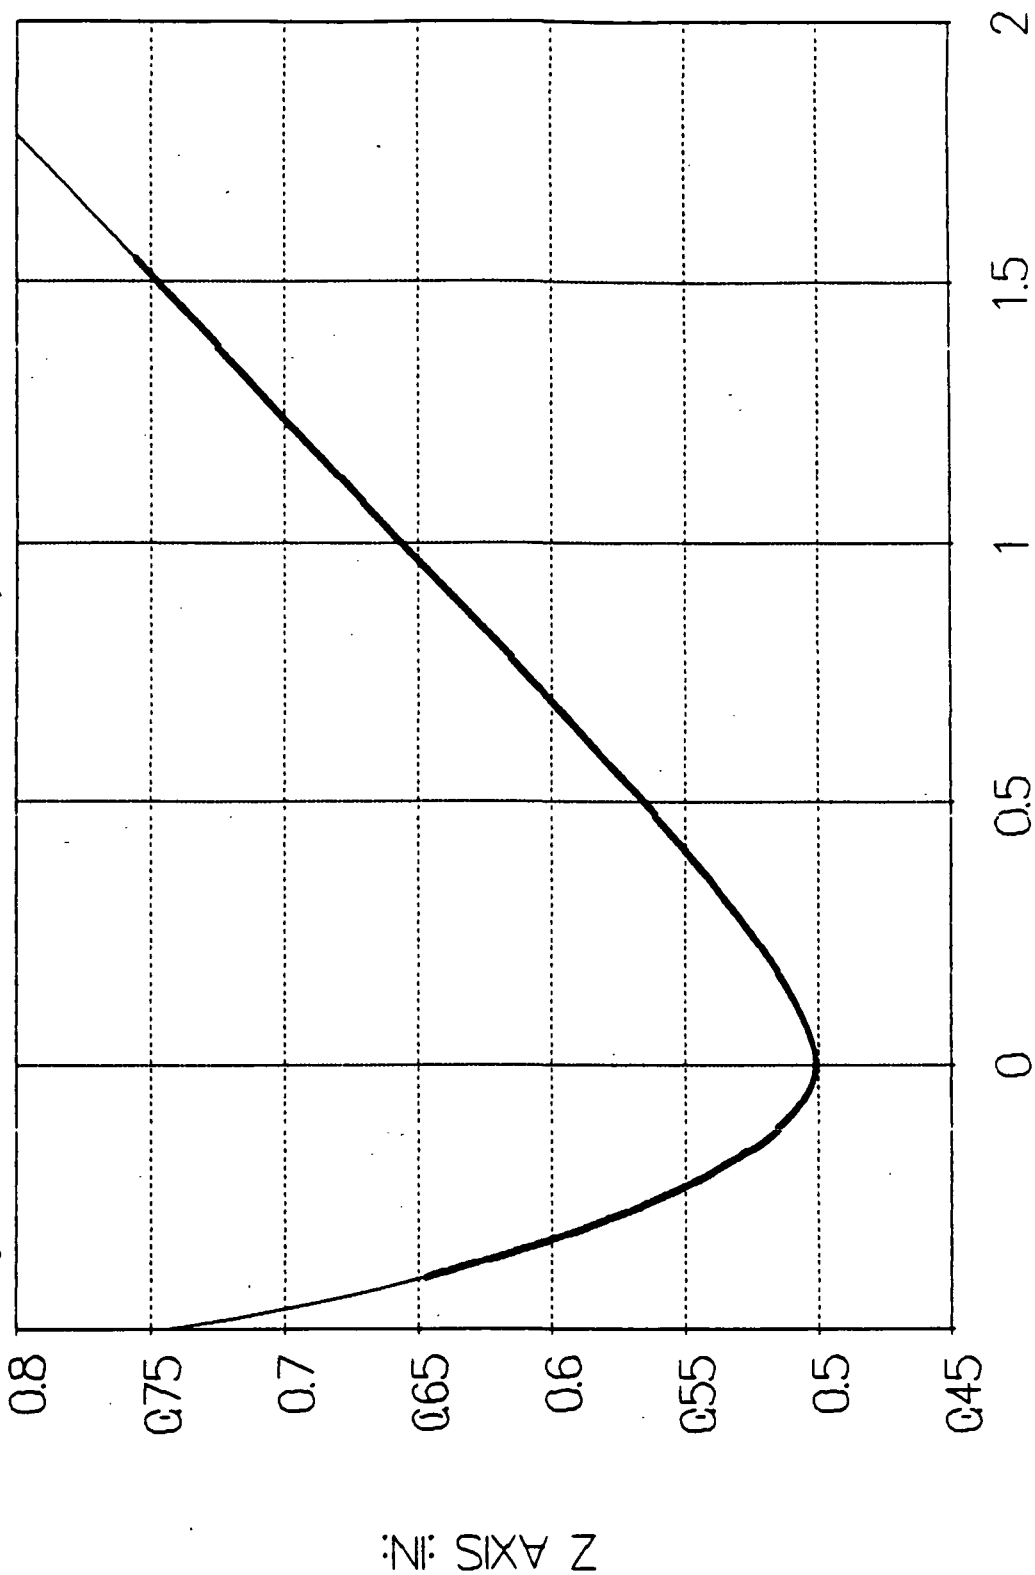
Fig 7d Polynomial Fit (Measured Data)

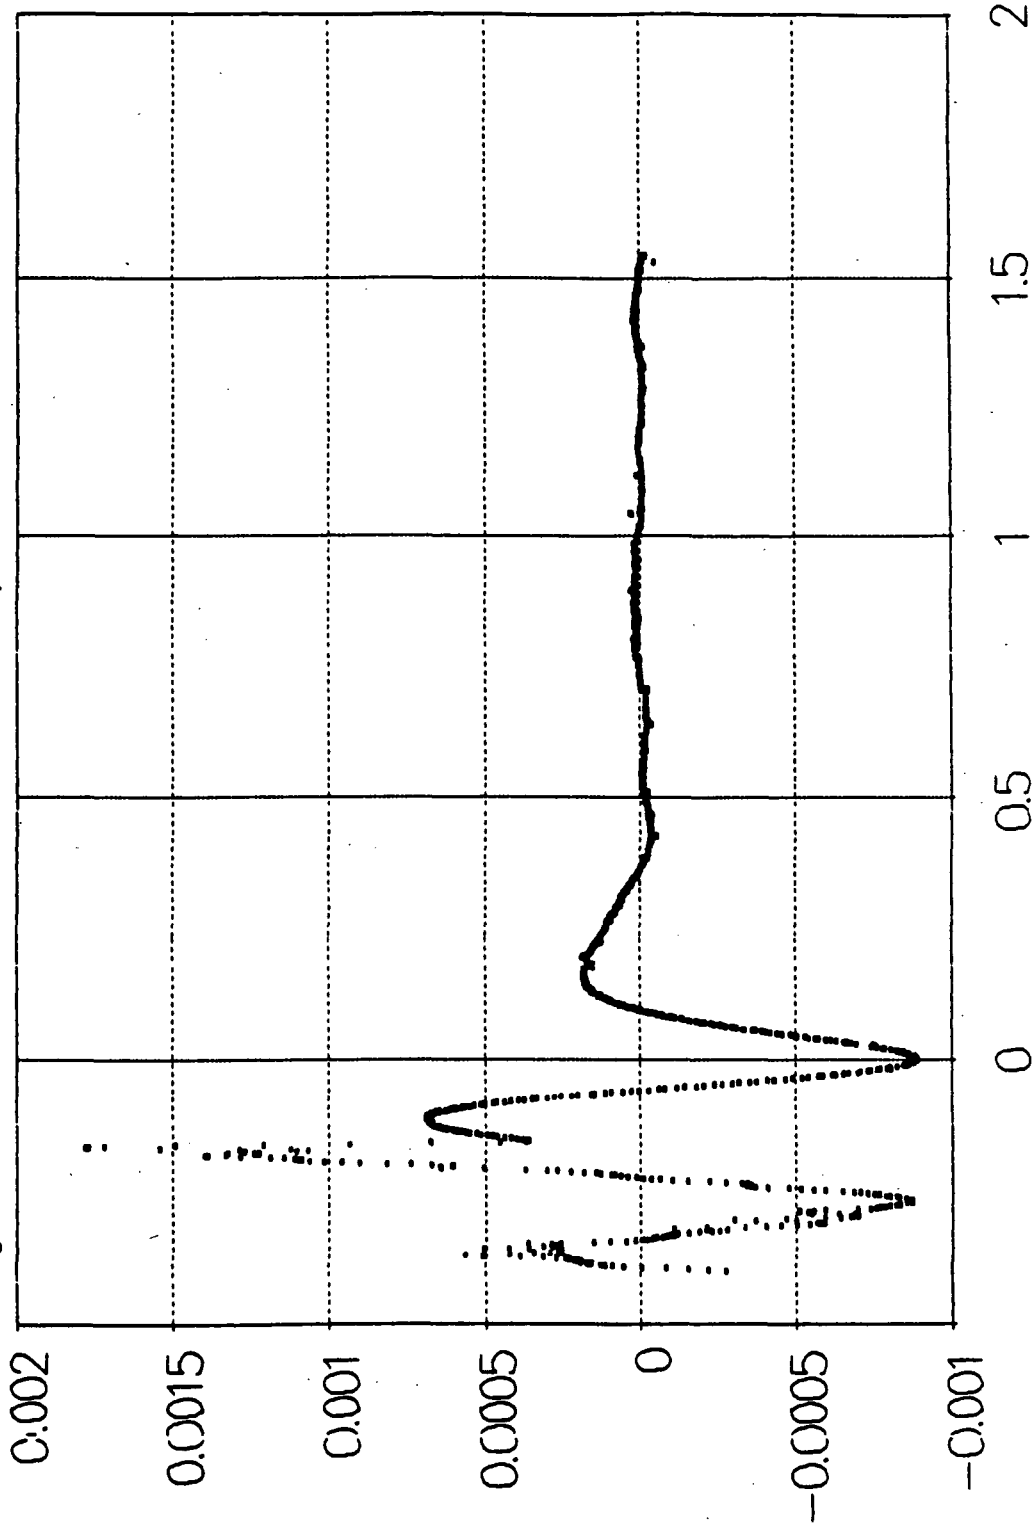
Fig. 7e Residual Error at Minimum (Measured Data)

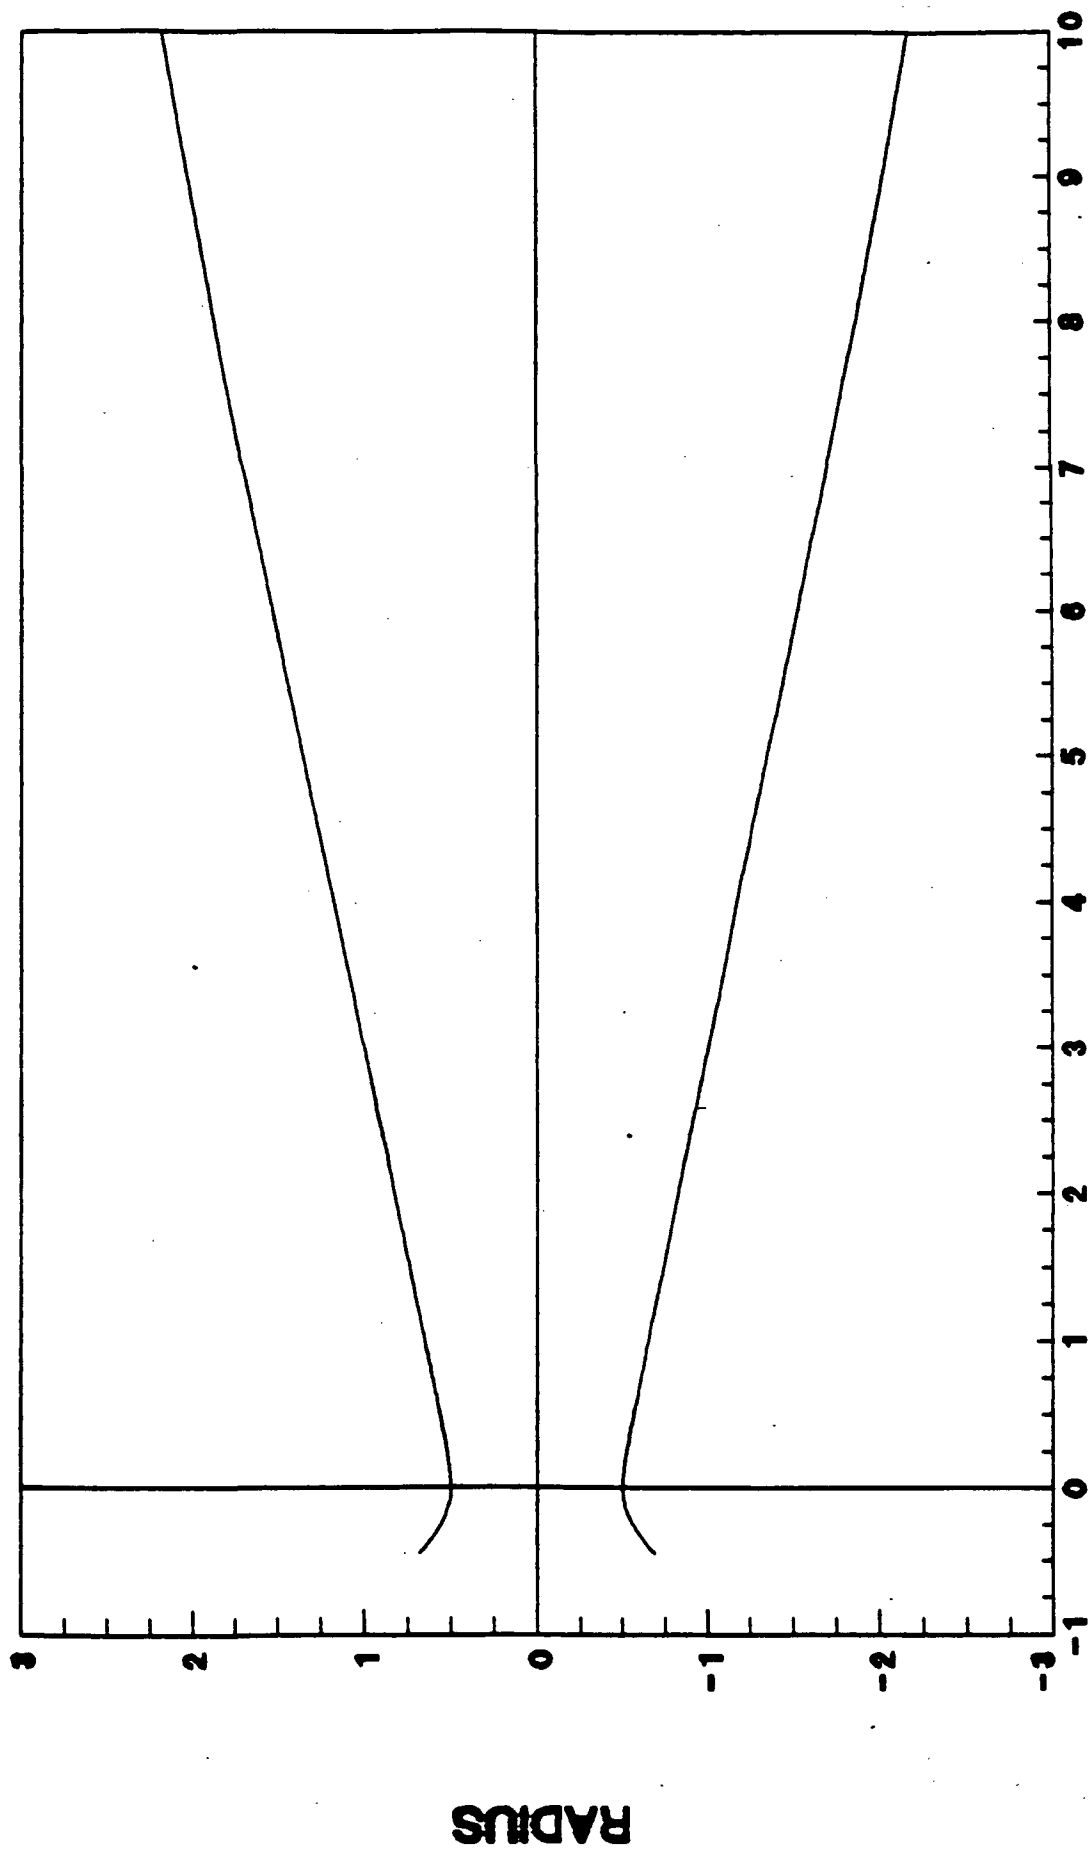
Fig 7h Original Data LENGTH

**WIND TUNNEL DATA
MACH 6 ELECTROFORMED**
